Manhole Inspection Summary

Manhole # S23EE1014MH

Insp Date: **3/15/07 12:55 PM**

Location Address: **1401 41ST ST**

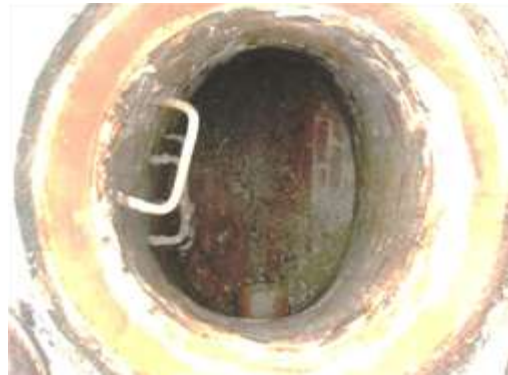
Top View

Channel debris.

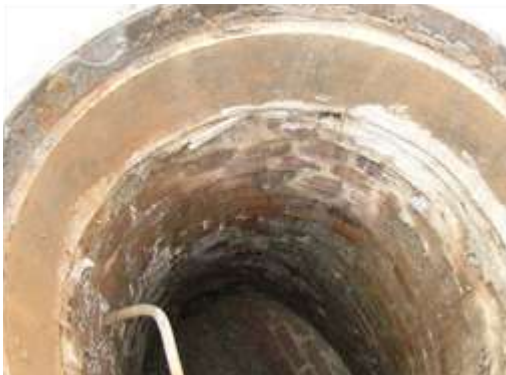
Defect

Frame leaks. Adjustment deterioration and infiltration. Corbel and Barrel infiltration.

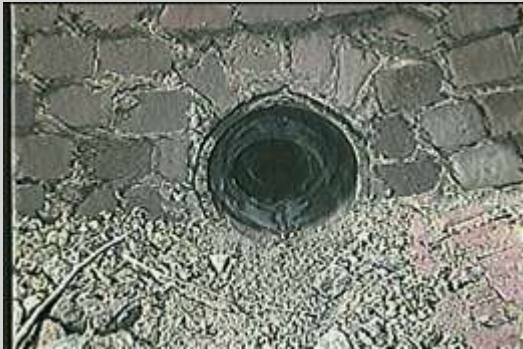
8 in. Circular Gravity Sewer Pipe Out @ 12 O'Clock

Offset joint inside.

Deposits: ☐ None ☐ Mud ☐ Sludge ☒ **Debris** ☒ **Grease**

Infiltration: **Evidence** Pipe Seal Cond: **Unknown**

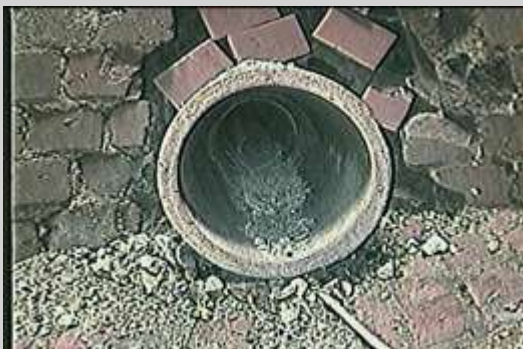
8 in. Circular Gravity Sewer Pipe In @ 6 O'Clock

Barrel deterioration, loose brick and infiltration.

Deposits: ☐ None ☐ Mud ☐ Sludge ☒ **Debris** ☒ **Grease**

Infiltration: **Evidence** Pipe Seal Cond: **Broken**
